MS355 Overview and Specifications

Overview

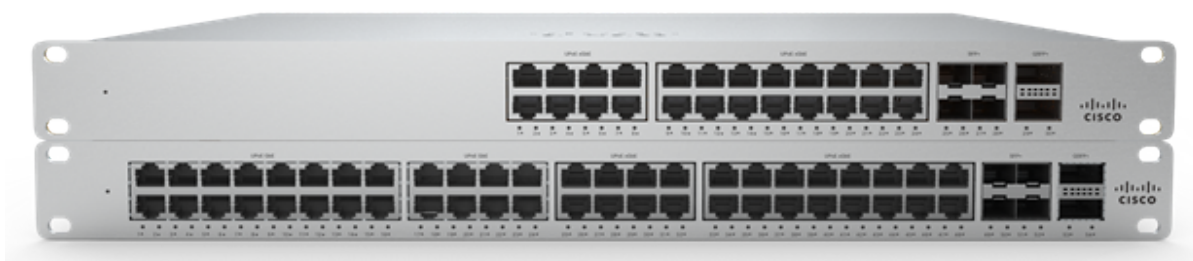
With 4 different models, each with multiple mGig RJ45 ports capable of negotiating up to 10Gbps, 40G QSFP+ ports, and dedicated 100G hardware stacking ports, the MS355 line is fully ready to support the future deployment of 802.11ax wireless infrastructure across a variety of different environments.
